34 BALLYVALLAGH RD BESS

Technical Clarification Report

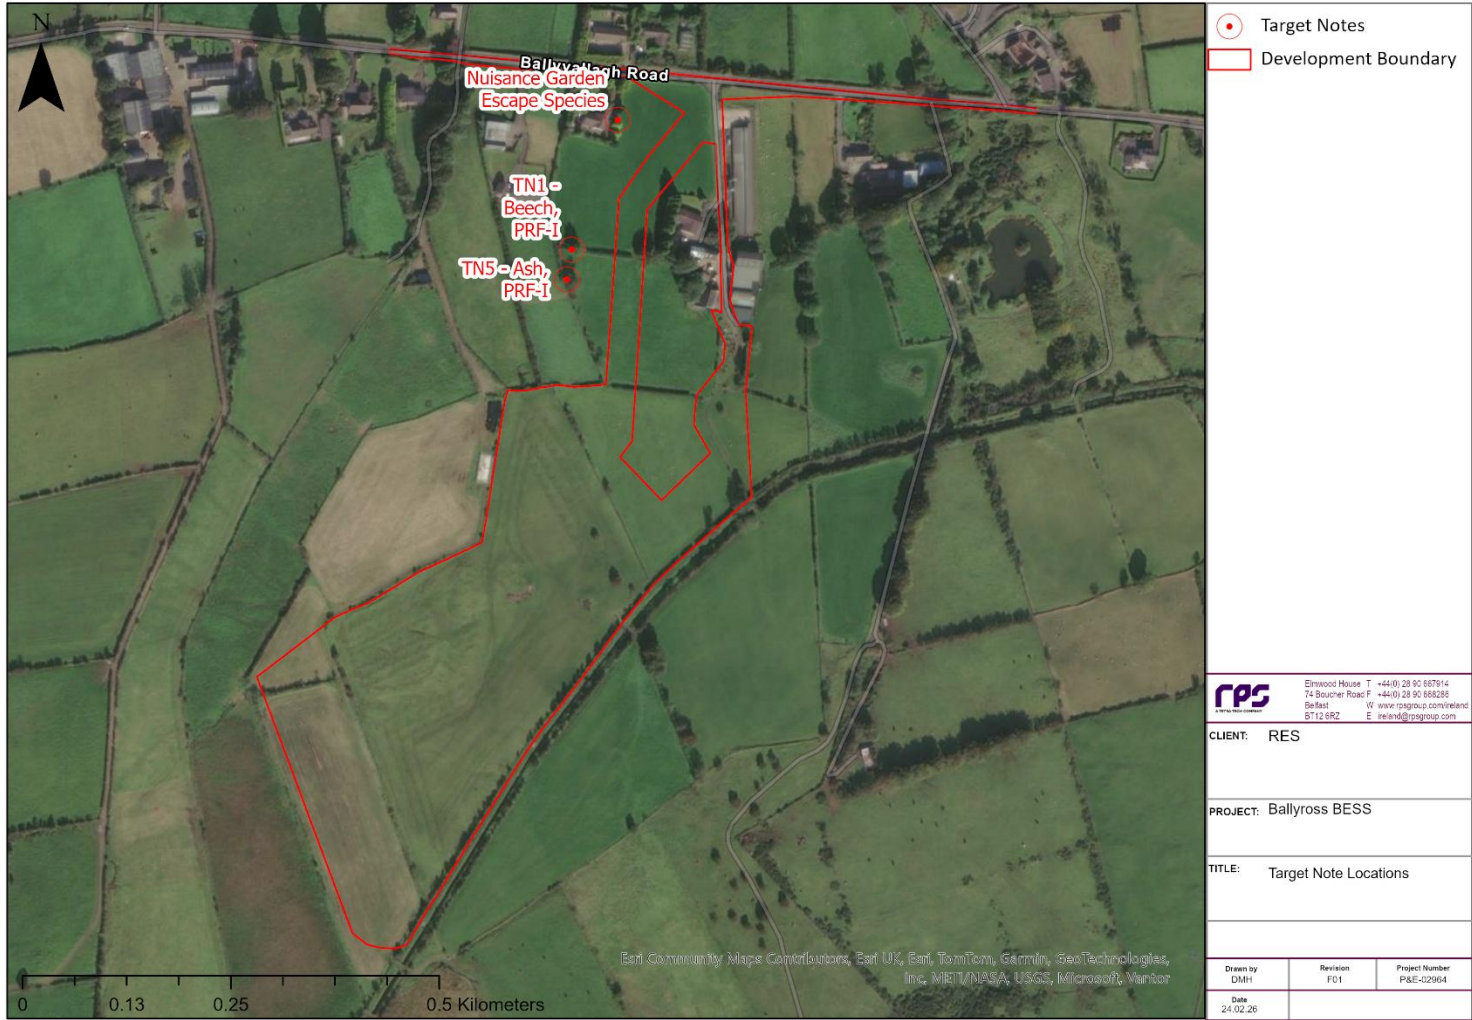
Figure 1.0 Target Note Locations

RPS has prepared the following map below (**Figure 1.0 Target Note Locations**) showing the proposed development boundary and the location of the two trees (TN1 and TN5) with PRF-I features. Both trees will be retained, and are located outside the development boundary. No works will occur on either tree.

The site boundary has been reduced in size since the habitat and species-specific surveys were conducted. Nuisance species and garden escapees are now found outside the boundary of the site (*rhododendron*, *winter heliotrope* and *cherry laurel*) (See **Figure 1.0 Target Note Locations**). These species will be removed/controlled if found within the proposed BESS development’s boundary.
